**2011/2012 Annual Inspection  
Report**

**HWY 384 HYDROLOGIC  
RESTORATION PROJECT  
(CS-21)**

State Project Number CS-21  
Priority Project List 2

February 23, 2012  
Cameron Parish

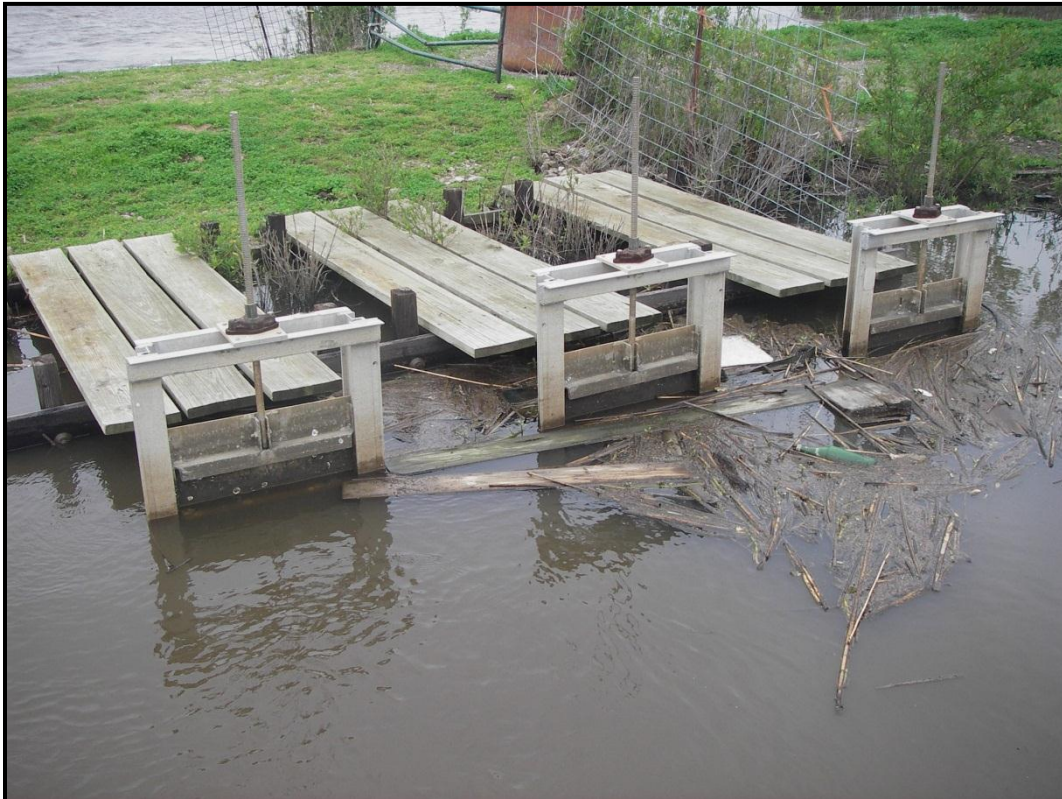
The structure is in good condition. The inside staff gage will need to be replaced. Rock placed on the bank during the maintenance event of June 2002 is stable and in no need of repair. The galvanized pile caps were recently replaced with plastic pile cap covers.

**Photo No. 1,** Structure No.1, inlet side.

- Replace staff gage.
- Repair vandalism.
- Repair/elevate levee.
- Clean out inlet channel.

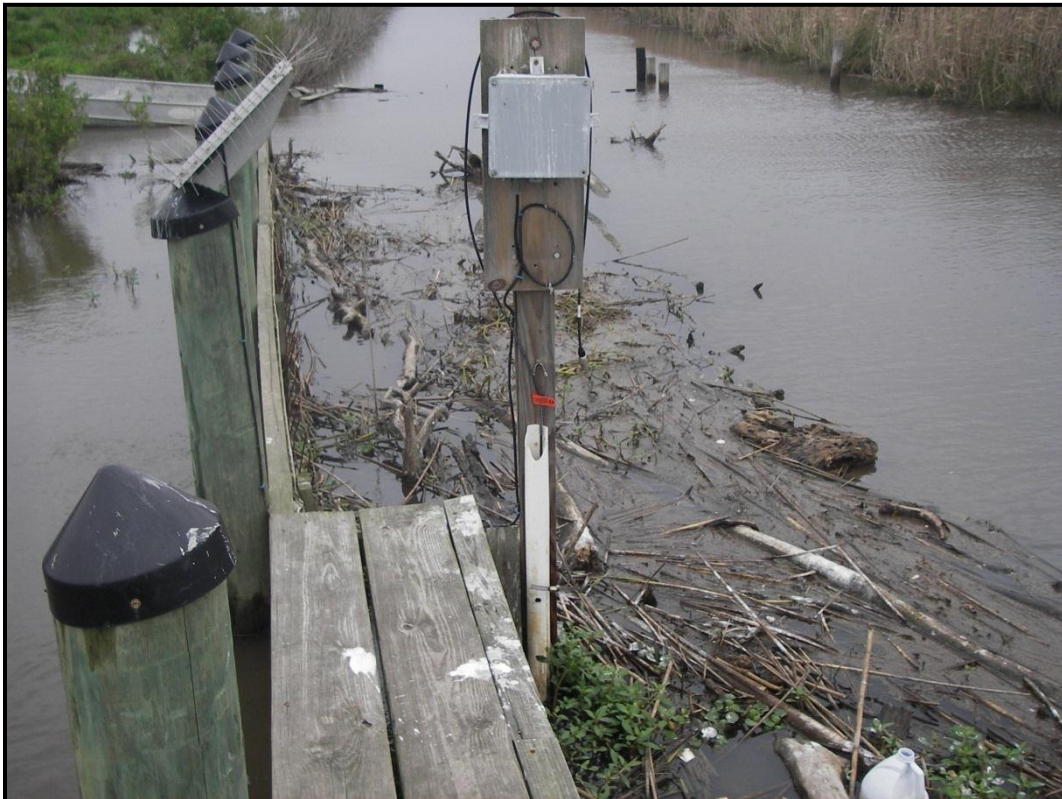
Water was flowing from the GIWW into the project area. All three gates were open and flap gates were flapping open. The operations contractor was contacted to check the three flap gates to ensure there were no obstructions such that they did not appear to be fully open. The hyacinth fence is in good condition. There is some trash accumulation in front of the hyacinth fence. This condition will be monitored and addressed if flow restriction becomes an issue. In addition the contract operator will submit a cost estimate to clean out the inlet side of the channel near the hyacinth fence. The road/levee leading up to the structure is in good condition since it was repaired in June 2006. The recently installed Portable Multi-Parameter Water Quality Troll 9500 – 29r operation sonde was operational, however on March 28, 2012 this office was notified by Chris Simon that the sonde had been vandalised. The solar panel, box cover and battery had been stolen. These items will need to be addressed. (Photos: Appendix B, Photos 1-3).

**Photo No. 2,** Structure No.1, hyacinth fence and operations equipment

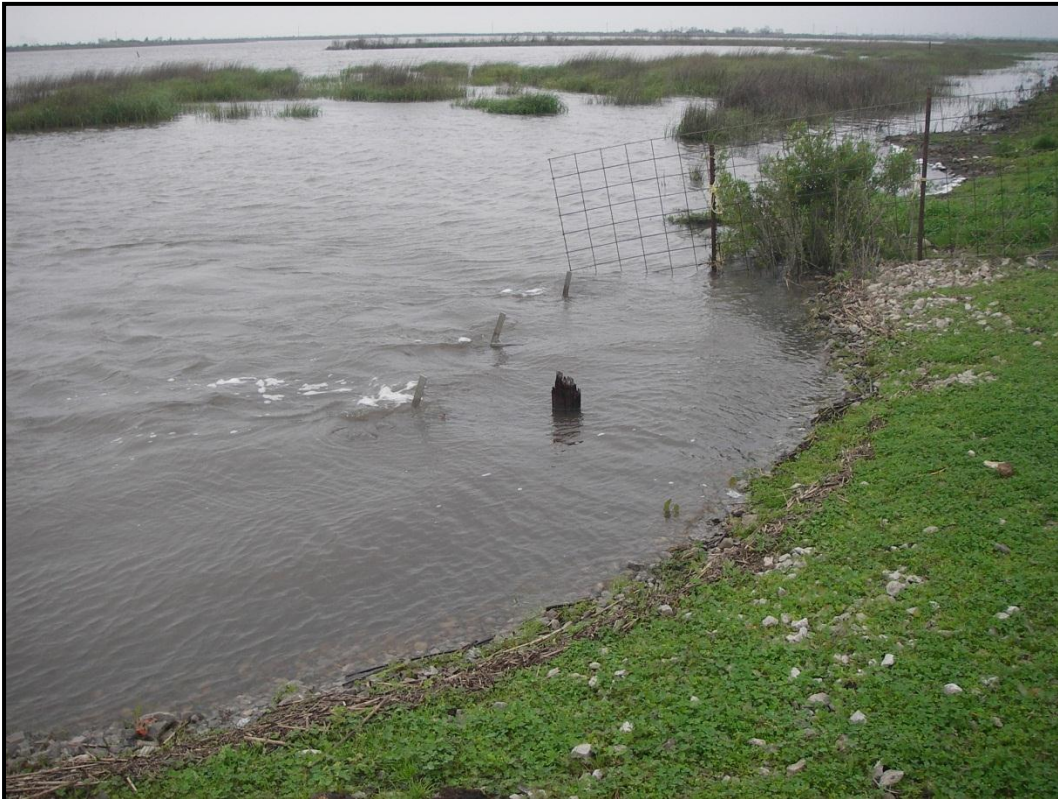
**Photo No.3**, Structure No.1, outlet side, flapgates open

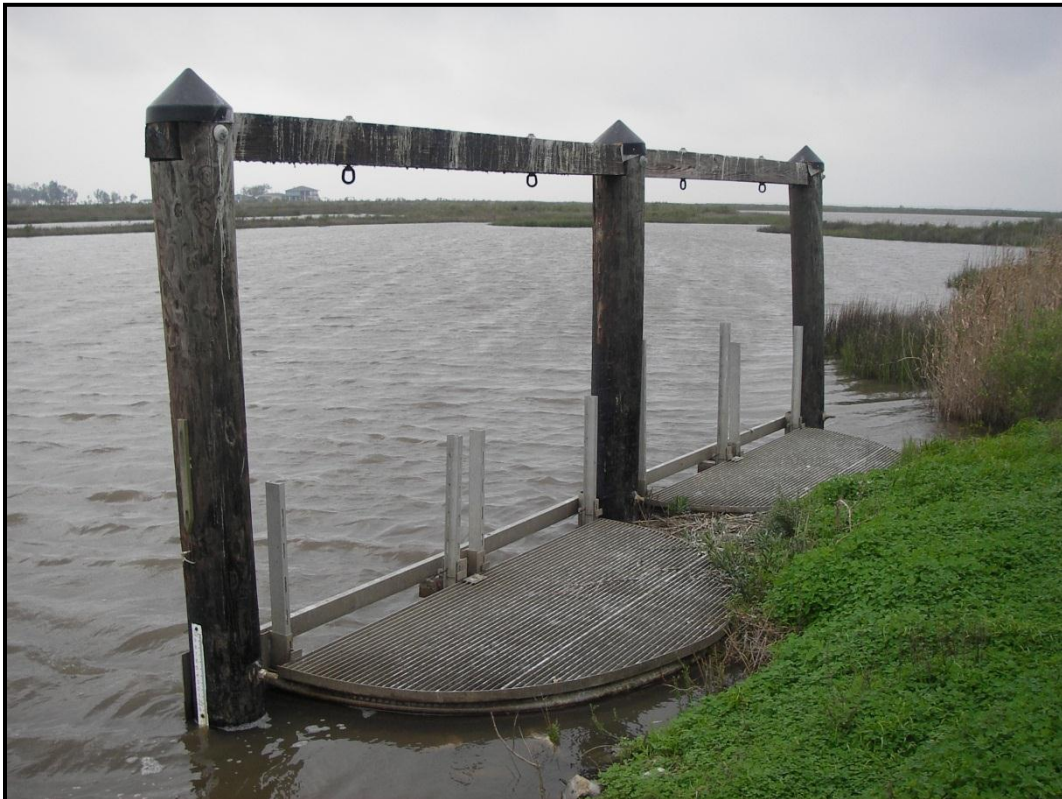
The structure is in good shape and the inlet and outlet sides appear undamaged. Water level on the outside was elevation +1.5 NAVD88 and the level inside was +1.7 NAVD88, and water was flowing from the interior to the lake side. Pile caps on the outlet side and inlet side have recently been replaced with plastic pile cap covers. Some of the lower anchor bolts on the structure show signs of corrosion and will be monitored. Rock that was placed during the maintenance of Nov. 2000 is stable. The road/levee leading up to the structure is in good condition since it was repaired in June 2006. (Photos: Appendix B, Photos 4-5).

**Photo No. 4**, Structure No. 12, inlet side.

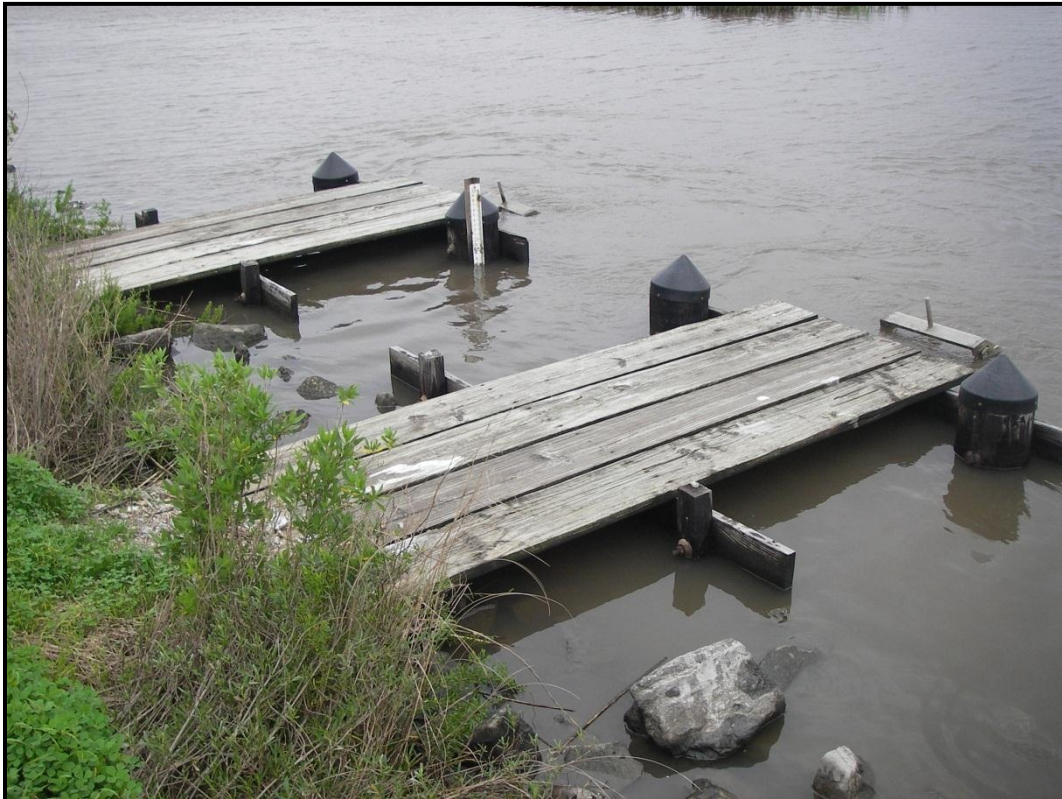
**Photo No. 5, Structure No. 12, outlet side.**

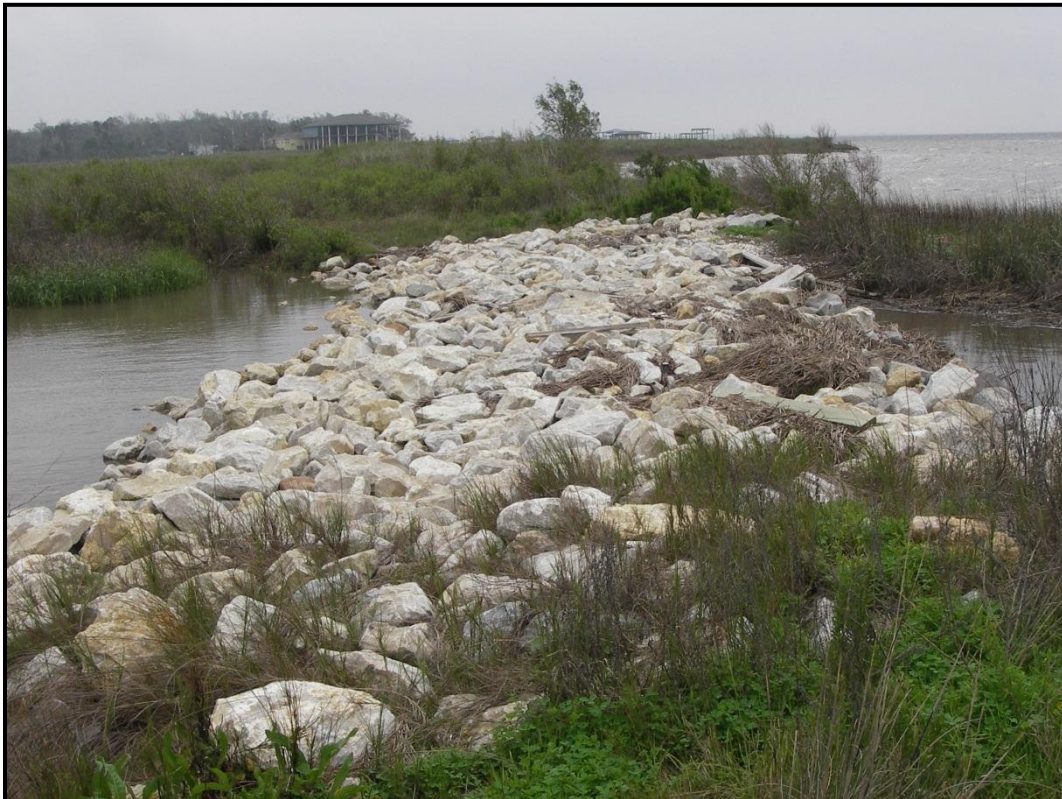
The rock plug is in good condition. It was determined by both NRCS and CPRA that the staff gages at this location do not need to be replaced such that there is no flow through this structure and the lake side has silted in and is covered with vegetation. The completed maintenance work in May 2005 to repair the plug from vandalism held up well under the high storm surge waters experienced during Hurricanes Rita and Ike. The interior area of the rock plug is showing signs of new vegetative growth in locations that were previously open water. The lakeside of the rock plug is also vegetating and is almost completely filled in. (Photos: Appendix B, Photos 6-8).

**Photo No. 6, Site No. 8, rock plug looking south**

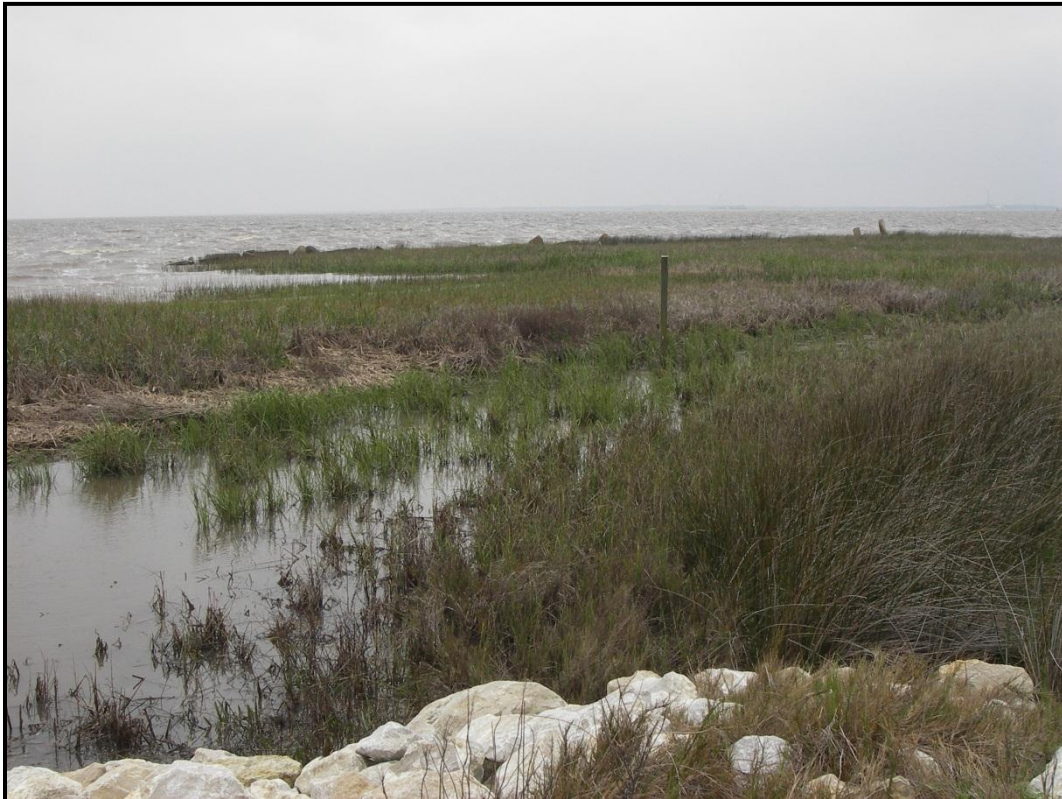
**Photo No. 7,** Site No. 8, rock plug showing vegetation lakeside

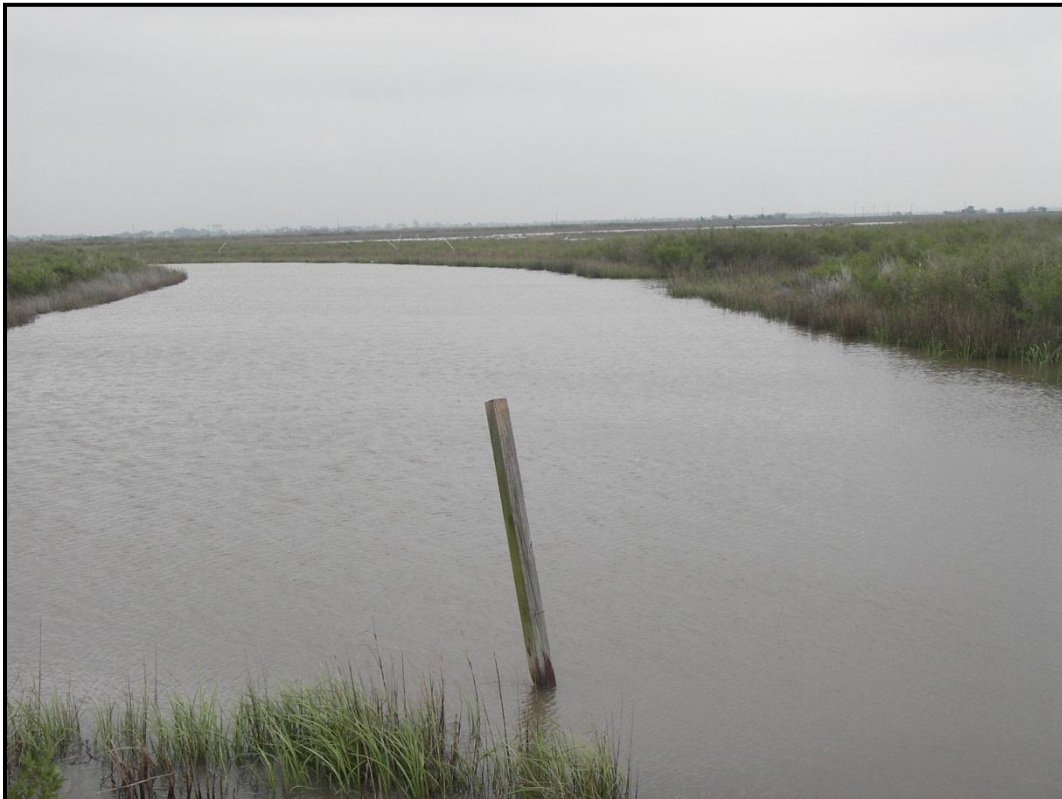
**Photo No. 8,** Site No. 8, rock plug showing vegetation on the interior

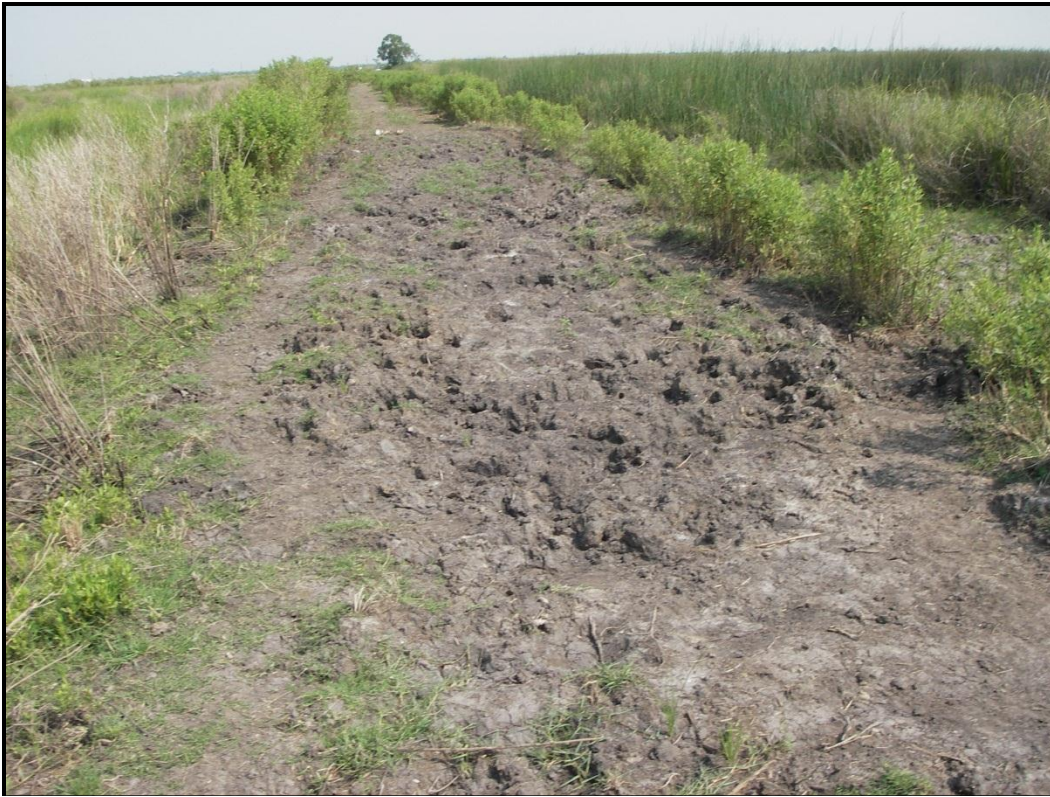
A supplemental site visit was conducted by CPRA and NRCS on May 21, 2012 to investigate levee erosion north of Structure #1 as requested by land owner, Buck Stevenson, and rice farmer Charles Precht. It was discovered that a section of levee approximately 86 feet in length has been washed out and is very low in elevation (near marsh level). There are also other sections of the levee that appear low and may be subject to overtopping in the future. These areas need to be addressed. (Photos: Appendix B, Photos 9-10).

**Photo No. 9,** Levee erosion north of Str. No. 1.

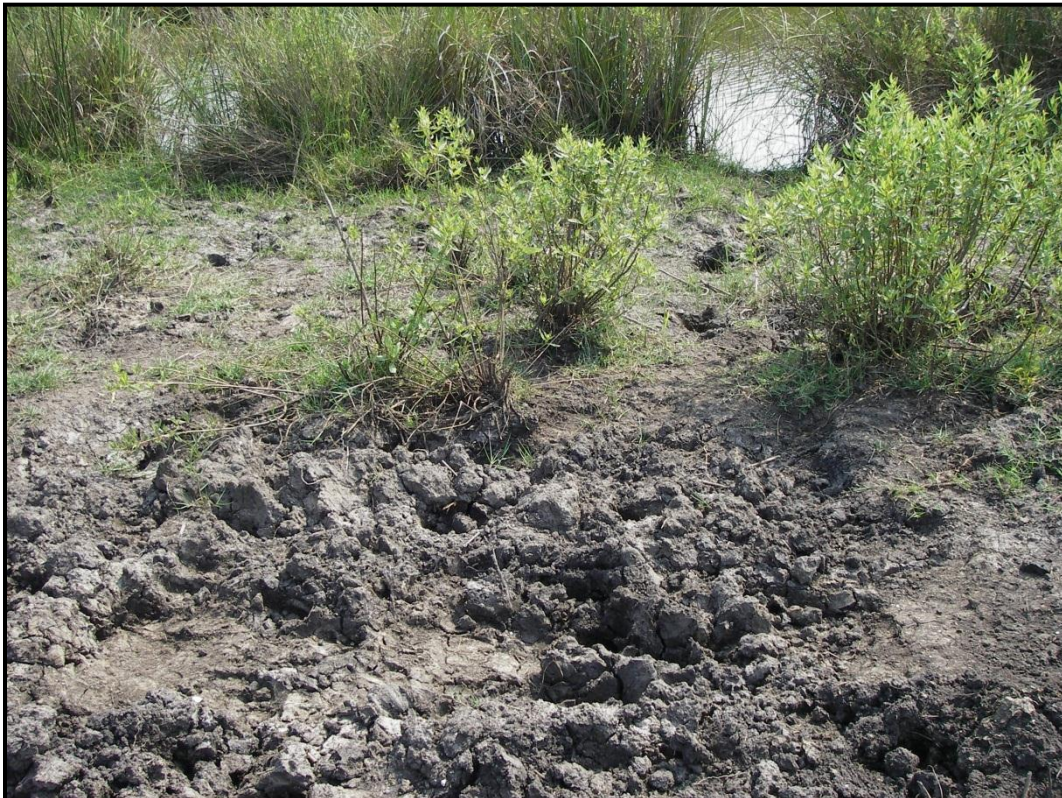
**Photo No. 10,** Levee erosion north of Str. No. 1, view looking towards marsh.
